Decatur/Barding & Spawr J.F.
ILD984 766 373

CERCLA Report

**Illinois Environmental
Protection Agency**

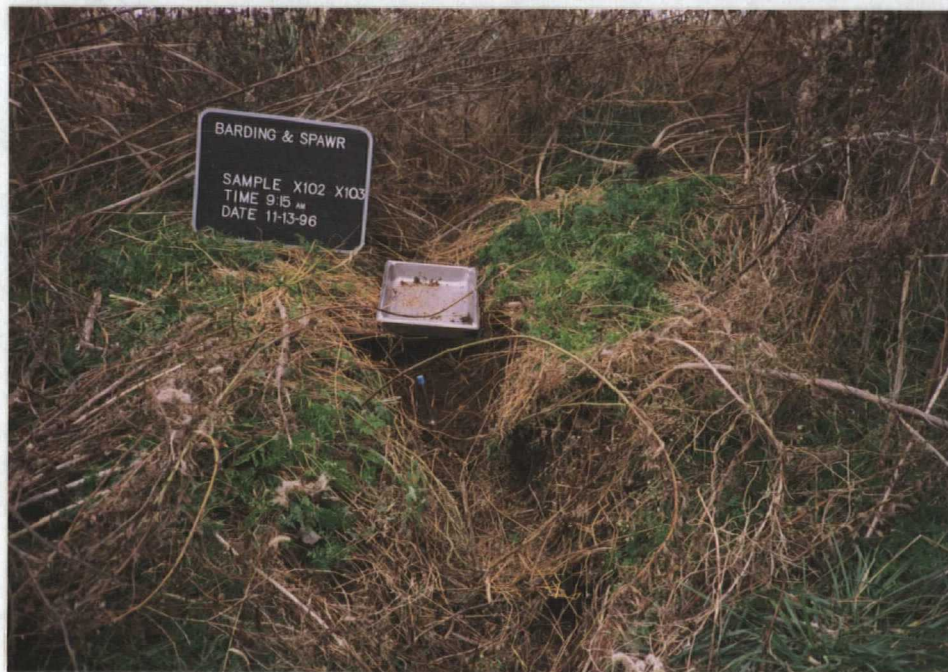
DATE: 11-13-96	ILD: 1158040012 COUNTY: Macon
TIME: 9:15 am	SITE NAME: Decatur/Barding & Spawr Landfill
PHOTOGRAPH TAKEN BY: J. Triller	 
COMMENTS: Picture taken toward: Northwest	
Duplicate sample	
location X102/X103	
Collected from	
east side of land-	
fill along Wyckles Road.

DATE: 11-13-96
TIME: 9:15 am
PHOTOGRAPH TAKEN BY: J. Triller
COMMENTS: Picture taken toward: West
Location of
duplicate samples
X102/X103.

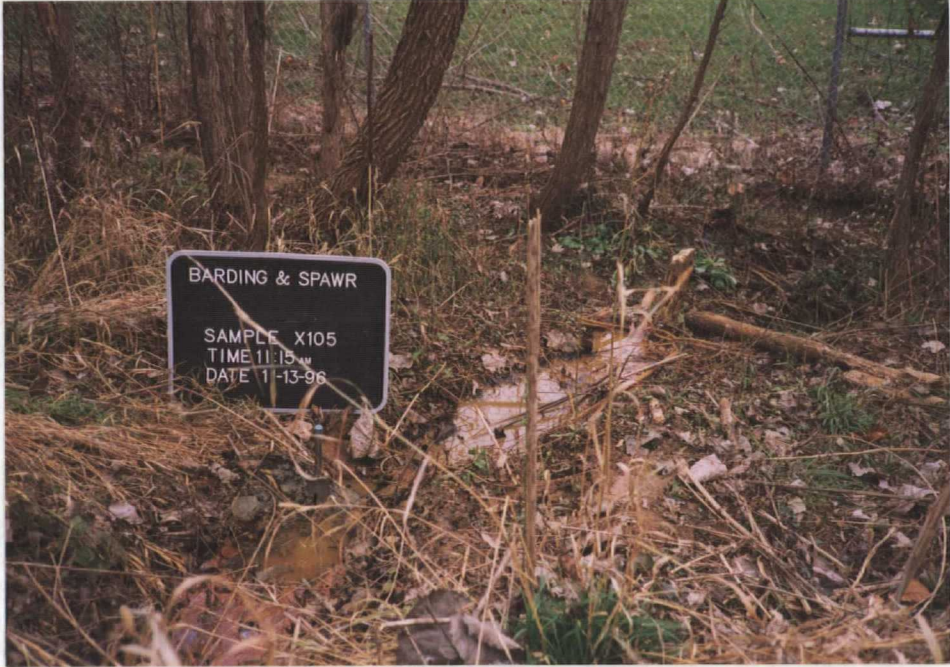
COMMENTS: Picture taken toward: East	
Sample X105,	
collected from	
bottom of leachate	
seep located on	
east side of land- fill.

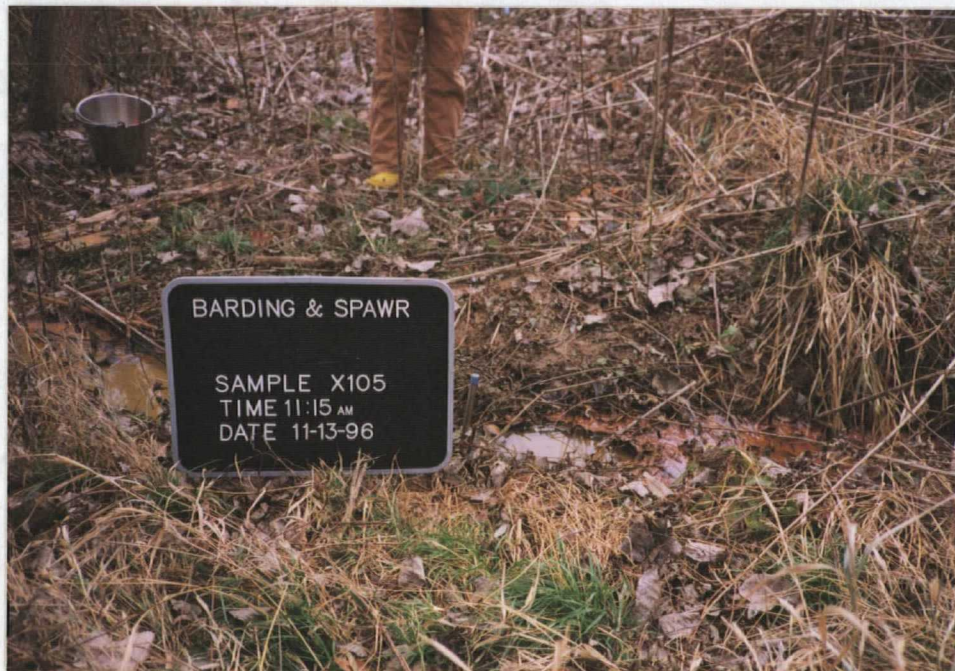
DATE: 11-13-96
TIME: 11:15 am
PHOTOGRAPH TAKEN BY: J. Triller
COMMENTS: Picture taken toward: Northeast
Sample location
X105.

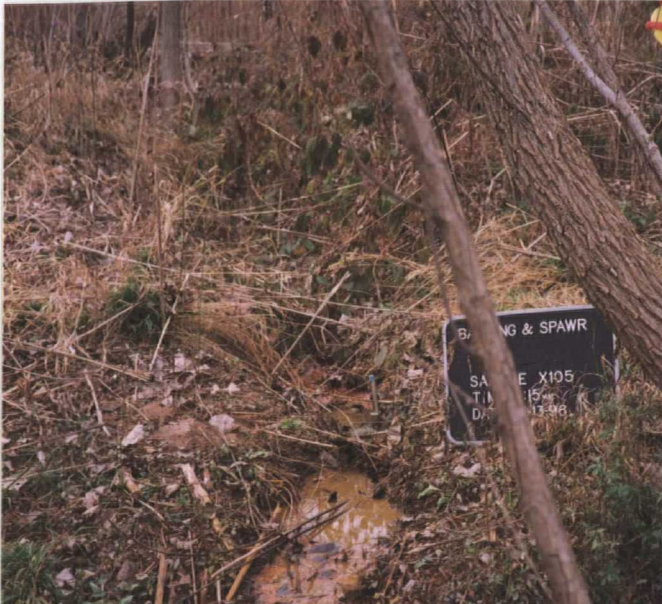
COMMENTS: Picture taken toward: West	
Sample location	
X105.

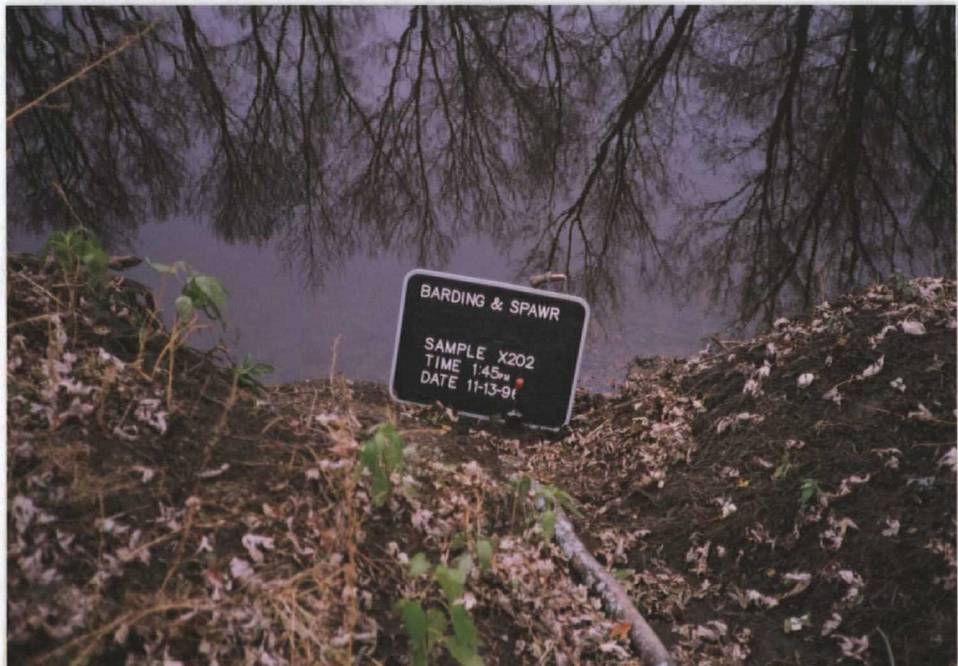
DATE: 11-13-96
TIME: 1:45 pm
PHOTOGRAPH TAKEN BY: J. Triller
COMMENTS: Picture taken toward: Southeast
Sample X202
collected from the
north side of
Sangamon River
at south border
of site.

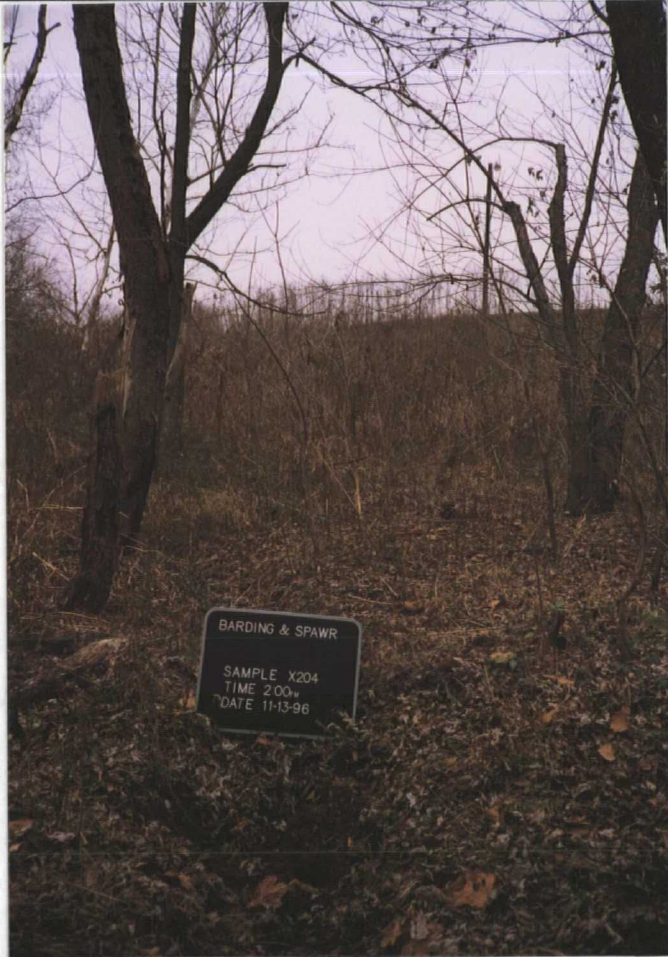
COMMENTS: Picture taken toward: North	
Sample X204	
collected from	
a dry ditch near	
southwest corner	
of sanitary dist. facility.

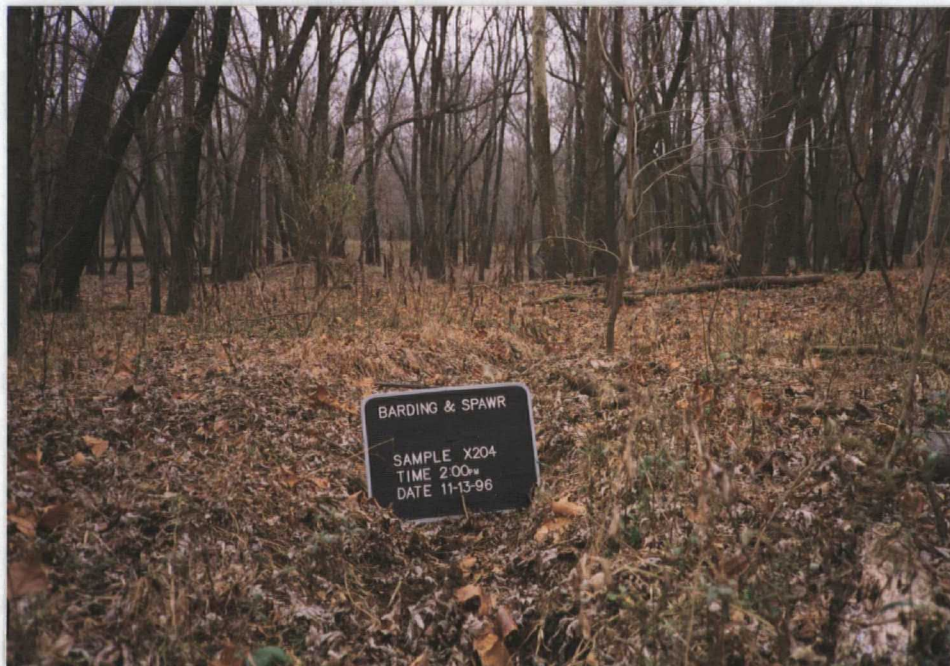
DATE: 11-13-96
TIME: 2:00 pm
PHOTOGRAPH TAKEN BY: J. Triller
COMMENTS: Picture taken toward: South
Sample location
X204.

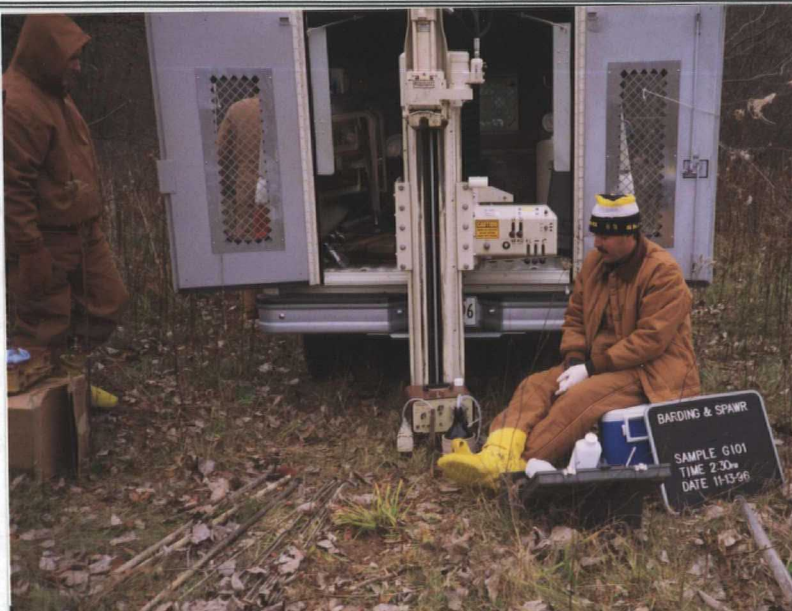
COMMENTS: Picture taken toward: Northeast	
Sample G101	
collected with	
GEOPROBE near southern edge of site.

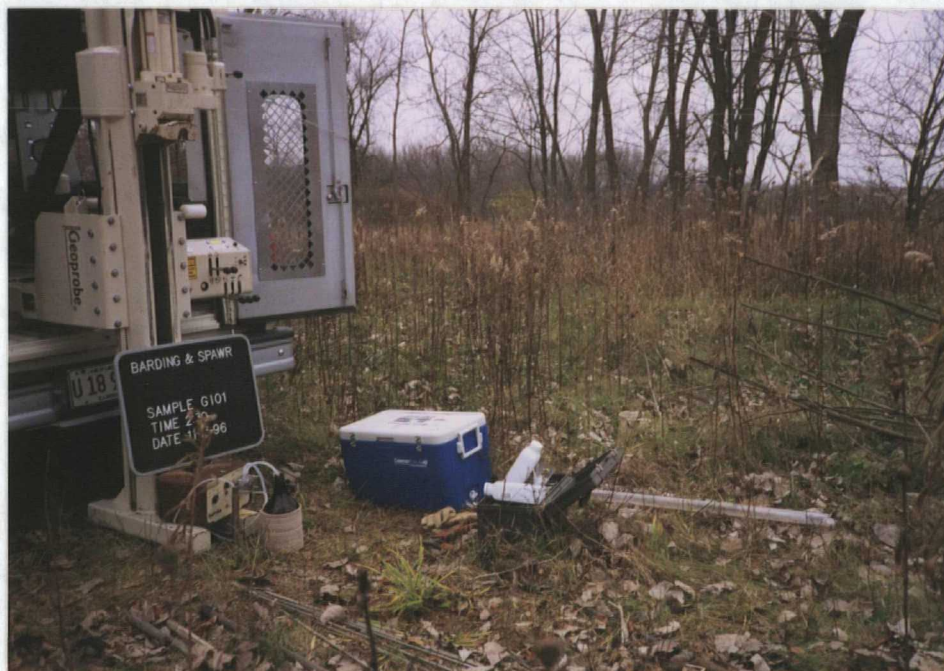
DATE: 11-13-96
TIME: 2:30 pm
PHOTOGRAPH TAKEN BY: J. Triller
COMMENTS: Picture taken toward: East
Sample point
G101.

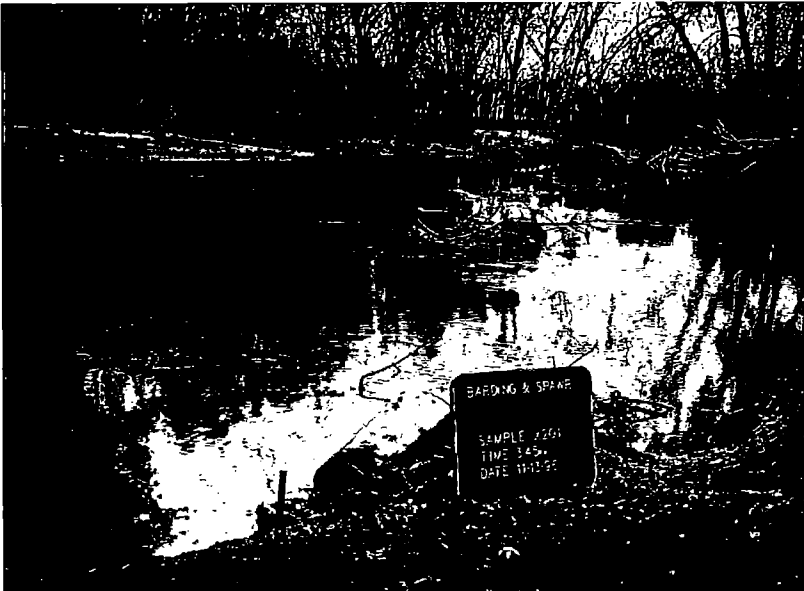
COMMENTS: Picture taken toward: Southeast	
Sample point X201	
located on north	
bank of Sangamon	
River, just east of Wyckles Road.

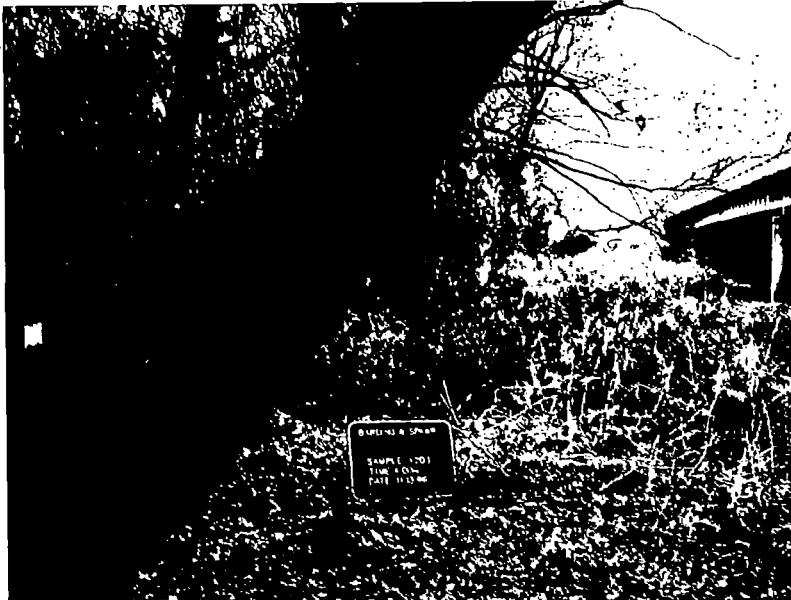
COMMENTS: Picture taken toward: Southeast	
Sample point X203	
located near	
north bank of	
Sangamon River, on east side of Wyckles Road.

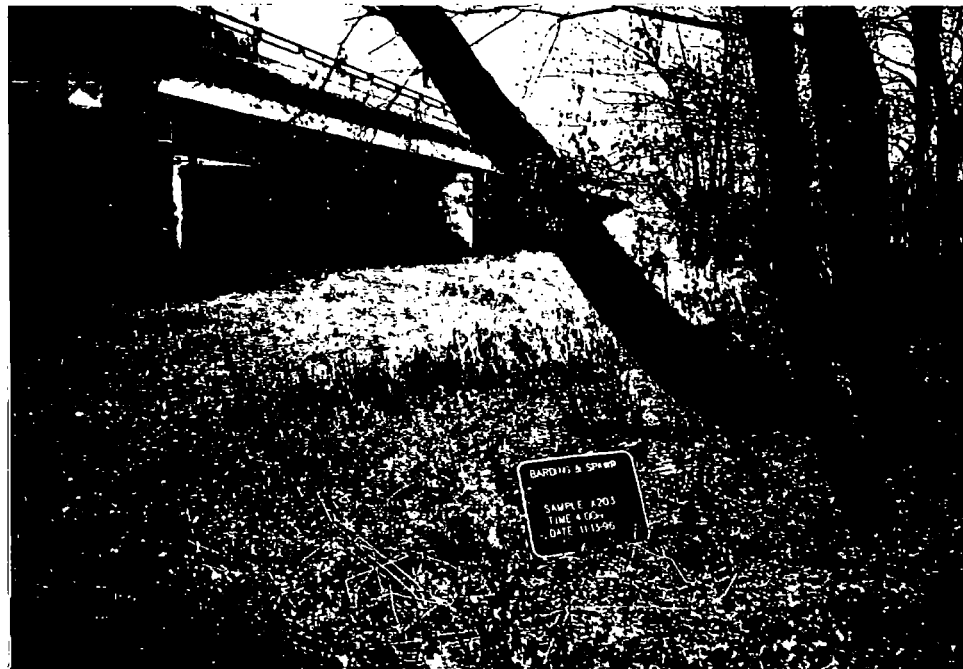
DATE: 11-13-96
TIME: 4:00 pm
PHOTOGRAPH TAKEN BY: Judy Triller
COMMENTS: Picture taken toward: Northwest
Sample point X203.

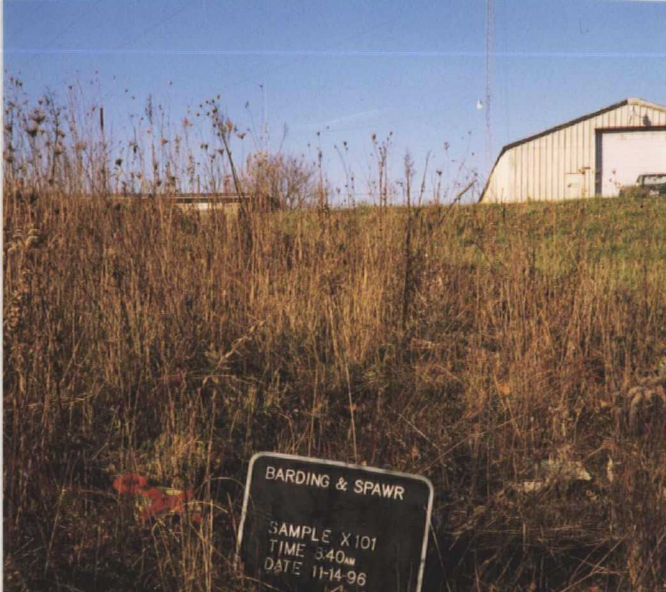
COMMENTS: Picture taken toward: West	
Sample X101 col-	
lected from east	
side of Wyckles	
Rd. across from Standard Waste office.

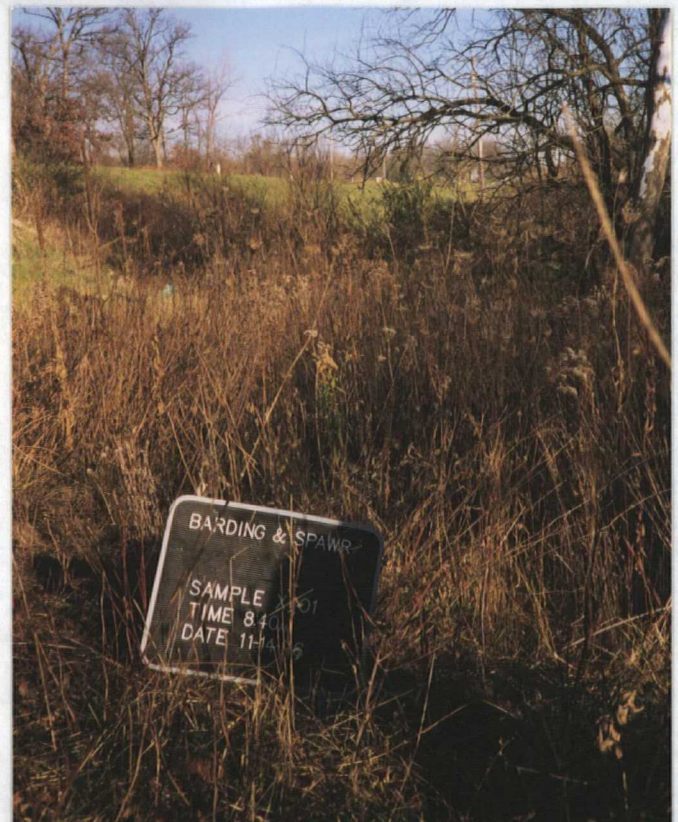
DATE: 11-14-96
TIME: 8:40 am
PHOTOGRAPH TAKEN BY: J. Triller
COMMENTS: Picture taken toward: Northwest
Sample point X101.

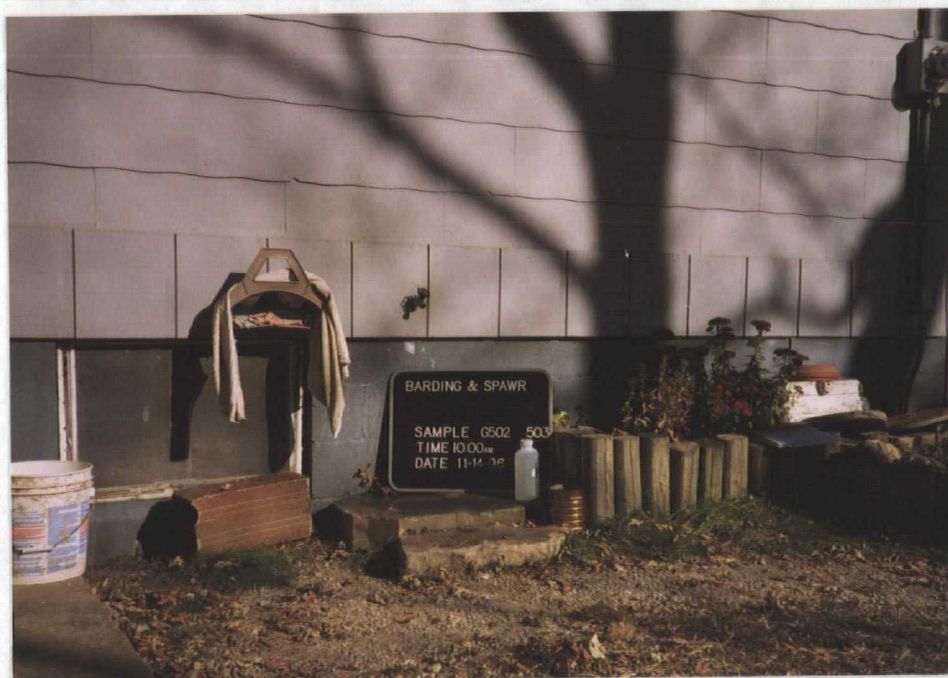
DATE: 11-14-96	ILD: 1158040012 COUNTY: Macon
TIME: 10:00 am	SITE NAME: Decatur/Barding & Spawr Landfill
PHOTOGRAPH TAKEN BY: J. Triller	
COMMENTS: Picture taken toward: North	
Duplicate samples	
G502/G503 collect-	
ed from residence	
on Bowsher Road,	
northwest of	
landfill.

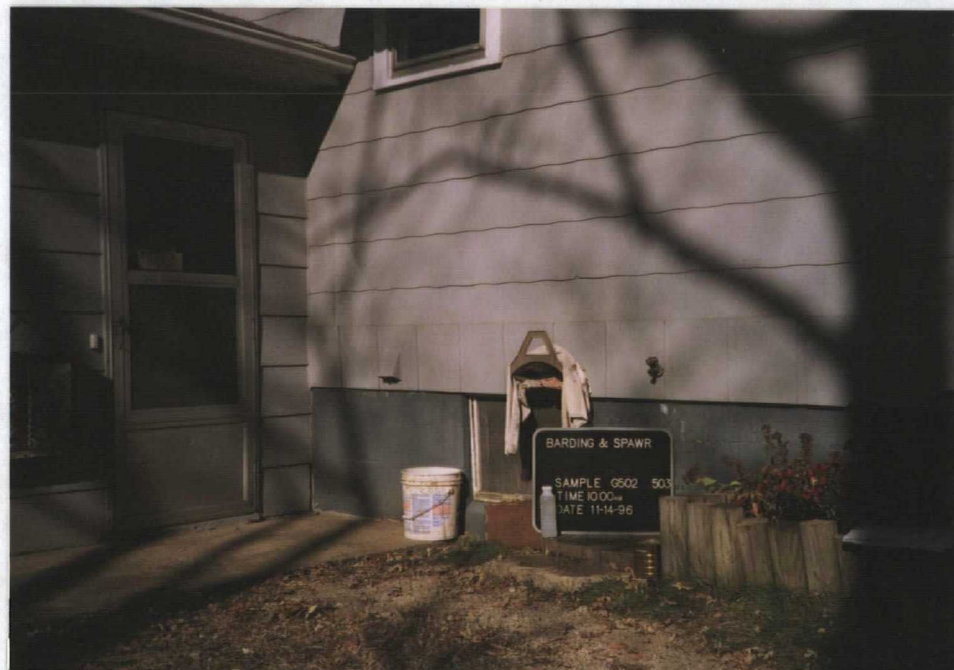
DATE: 11-14-96
TIME: 10:00 am
PHOTOGRAPH TAKEN BY: J. Triller
COMMENTS: Picture taken toward: Northwest
Duplicate samples
G502/G503.

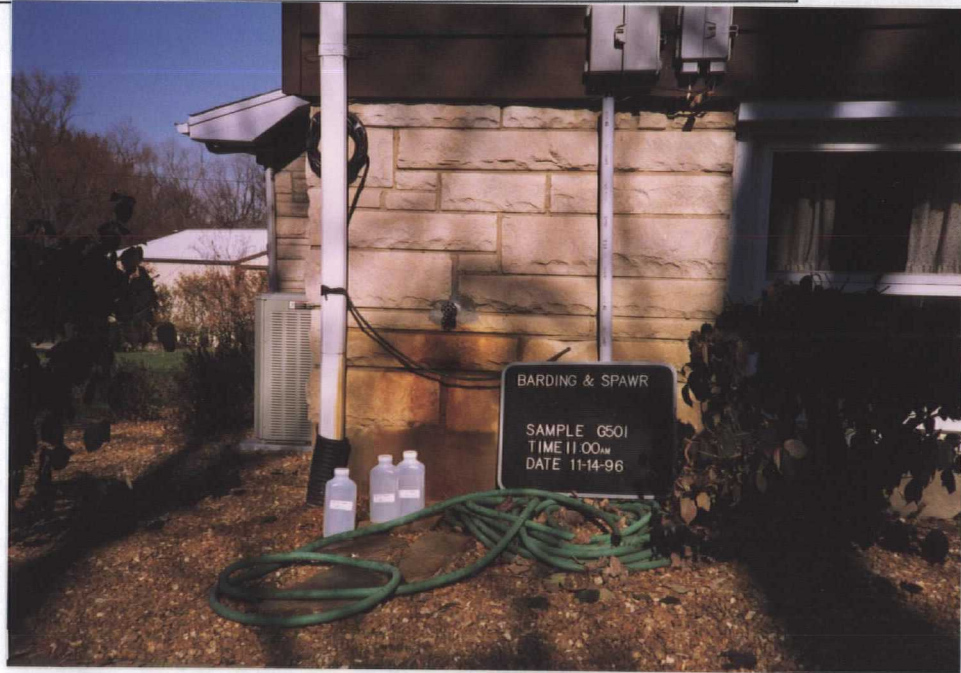
DATE: 11-14-96	ILD: 1158040012 COUNTY: Macon
TIME: 11:00 am	SITE NAME: Decatur/Barding & Spawr Landfill
PHOTOGRAPH TAKEN BY: J. Triller	
COMMENTS: Picture taken toward: North	
Sample point G501	
collected from	
Conservation	
office, southeast	
of site.

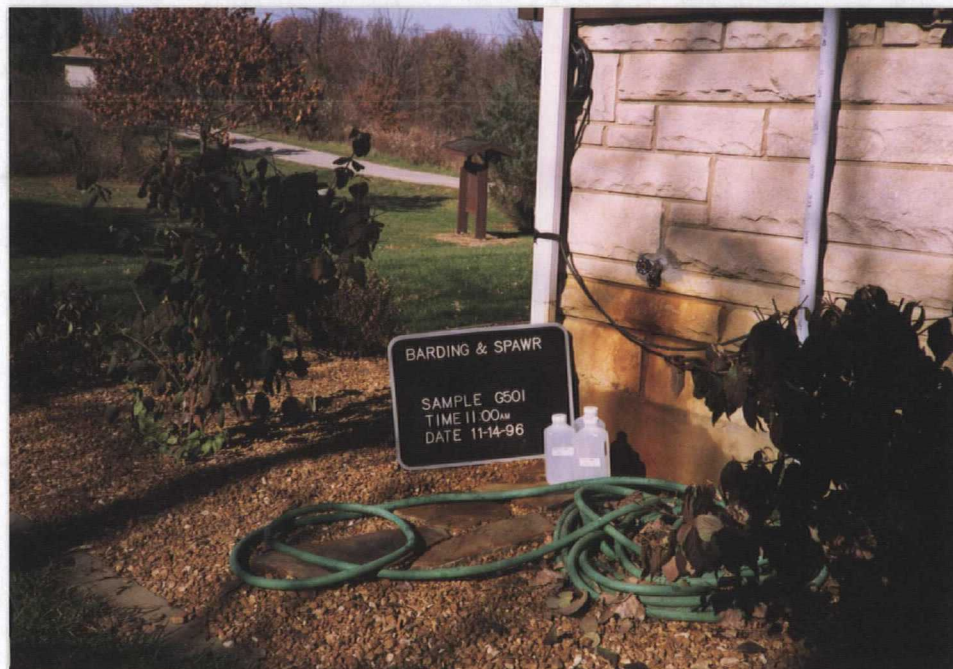
DATE: 11-14-96
TIME: 11:00 am
PHOTOGRAPH TAKEN BY: J. Triller
COMMENTS: Picture taken toward: Northwest
Sample point G501.

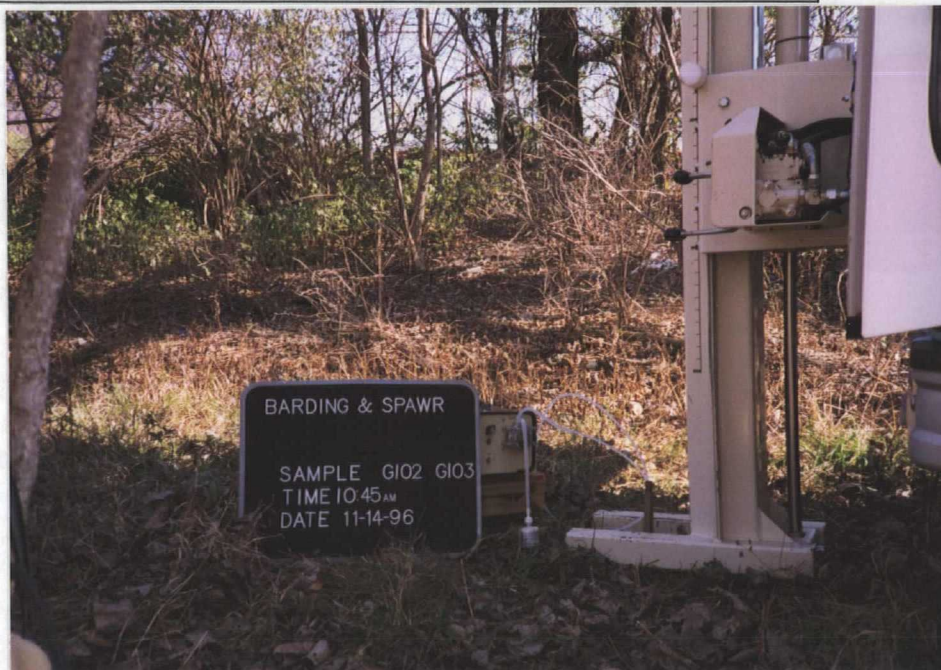
DATE: 11-14-96	ILD: 1158040012 COUNTY: Macon
TIME: 10:45 am	SITE NAME: Decatur/Barding & Spawr Landfill
PHOTOGRAPH TAKEN BY: J. Triller	
COMMENTS: Picture taken toward: East	
Duplicate samples	
G102/G103 collect-	
ed with GEOPROBE	
near center of	
site.

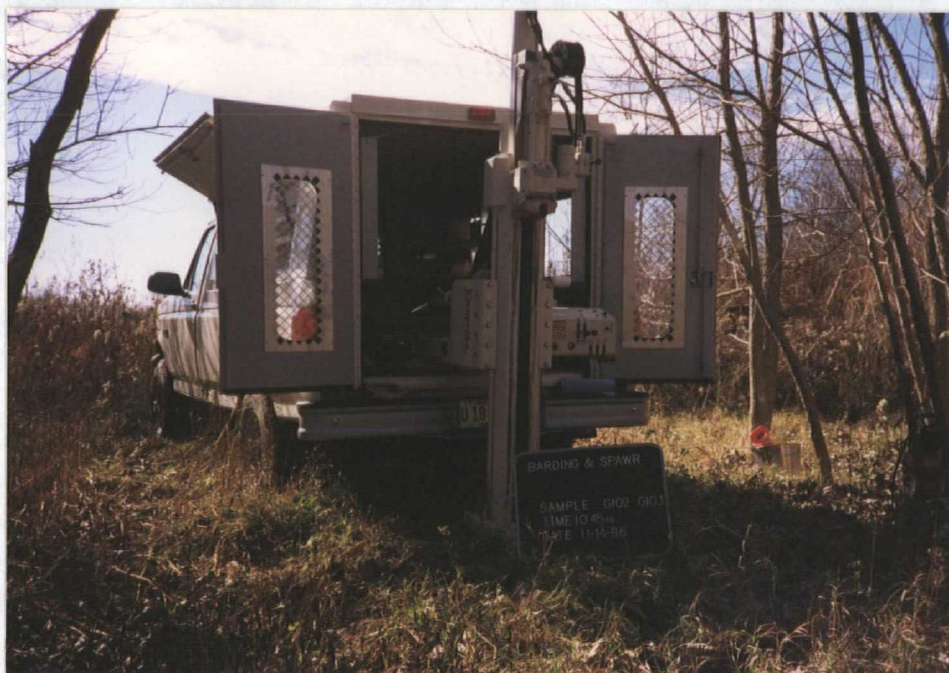
DATE: 11-14-96
TIME: 10:45 am
PHOTOGRAPH TAKEN BY: J. Triller
COMMENTS: Picture taken toward: Southwest
Duplicate samples
G102/G103.
